CEGIS

CENTER FOR ENVIRONMENTAL AND
GEOGRAPHIC INFORMATION SERVICES

LANDSAT TM IMAGE MOSAIC OF BANGLADESH, 1997

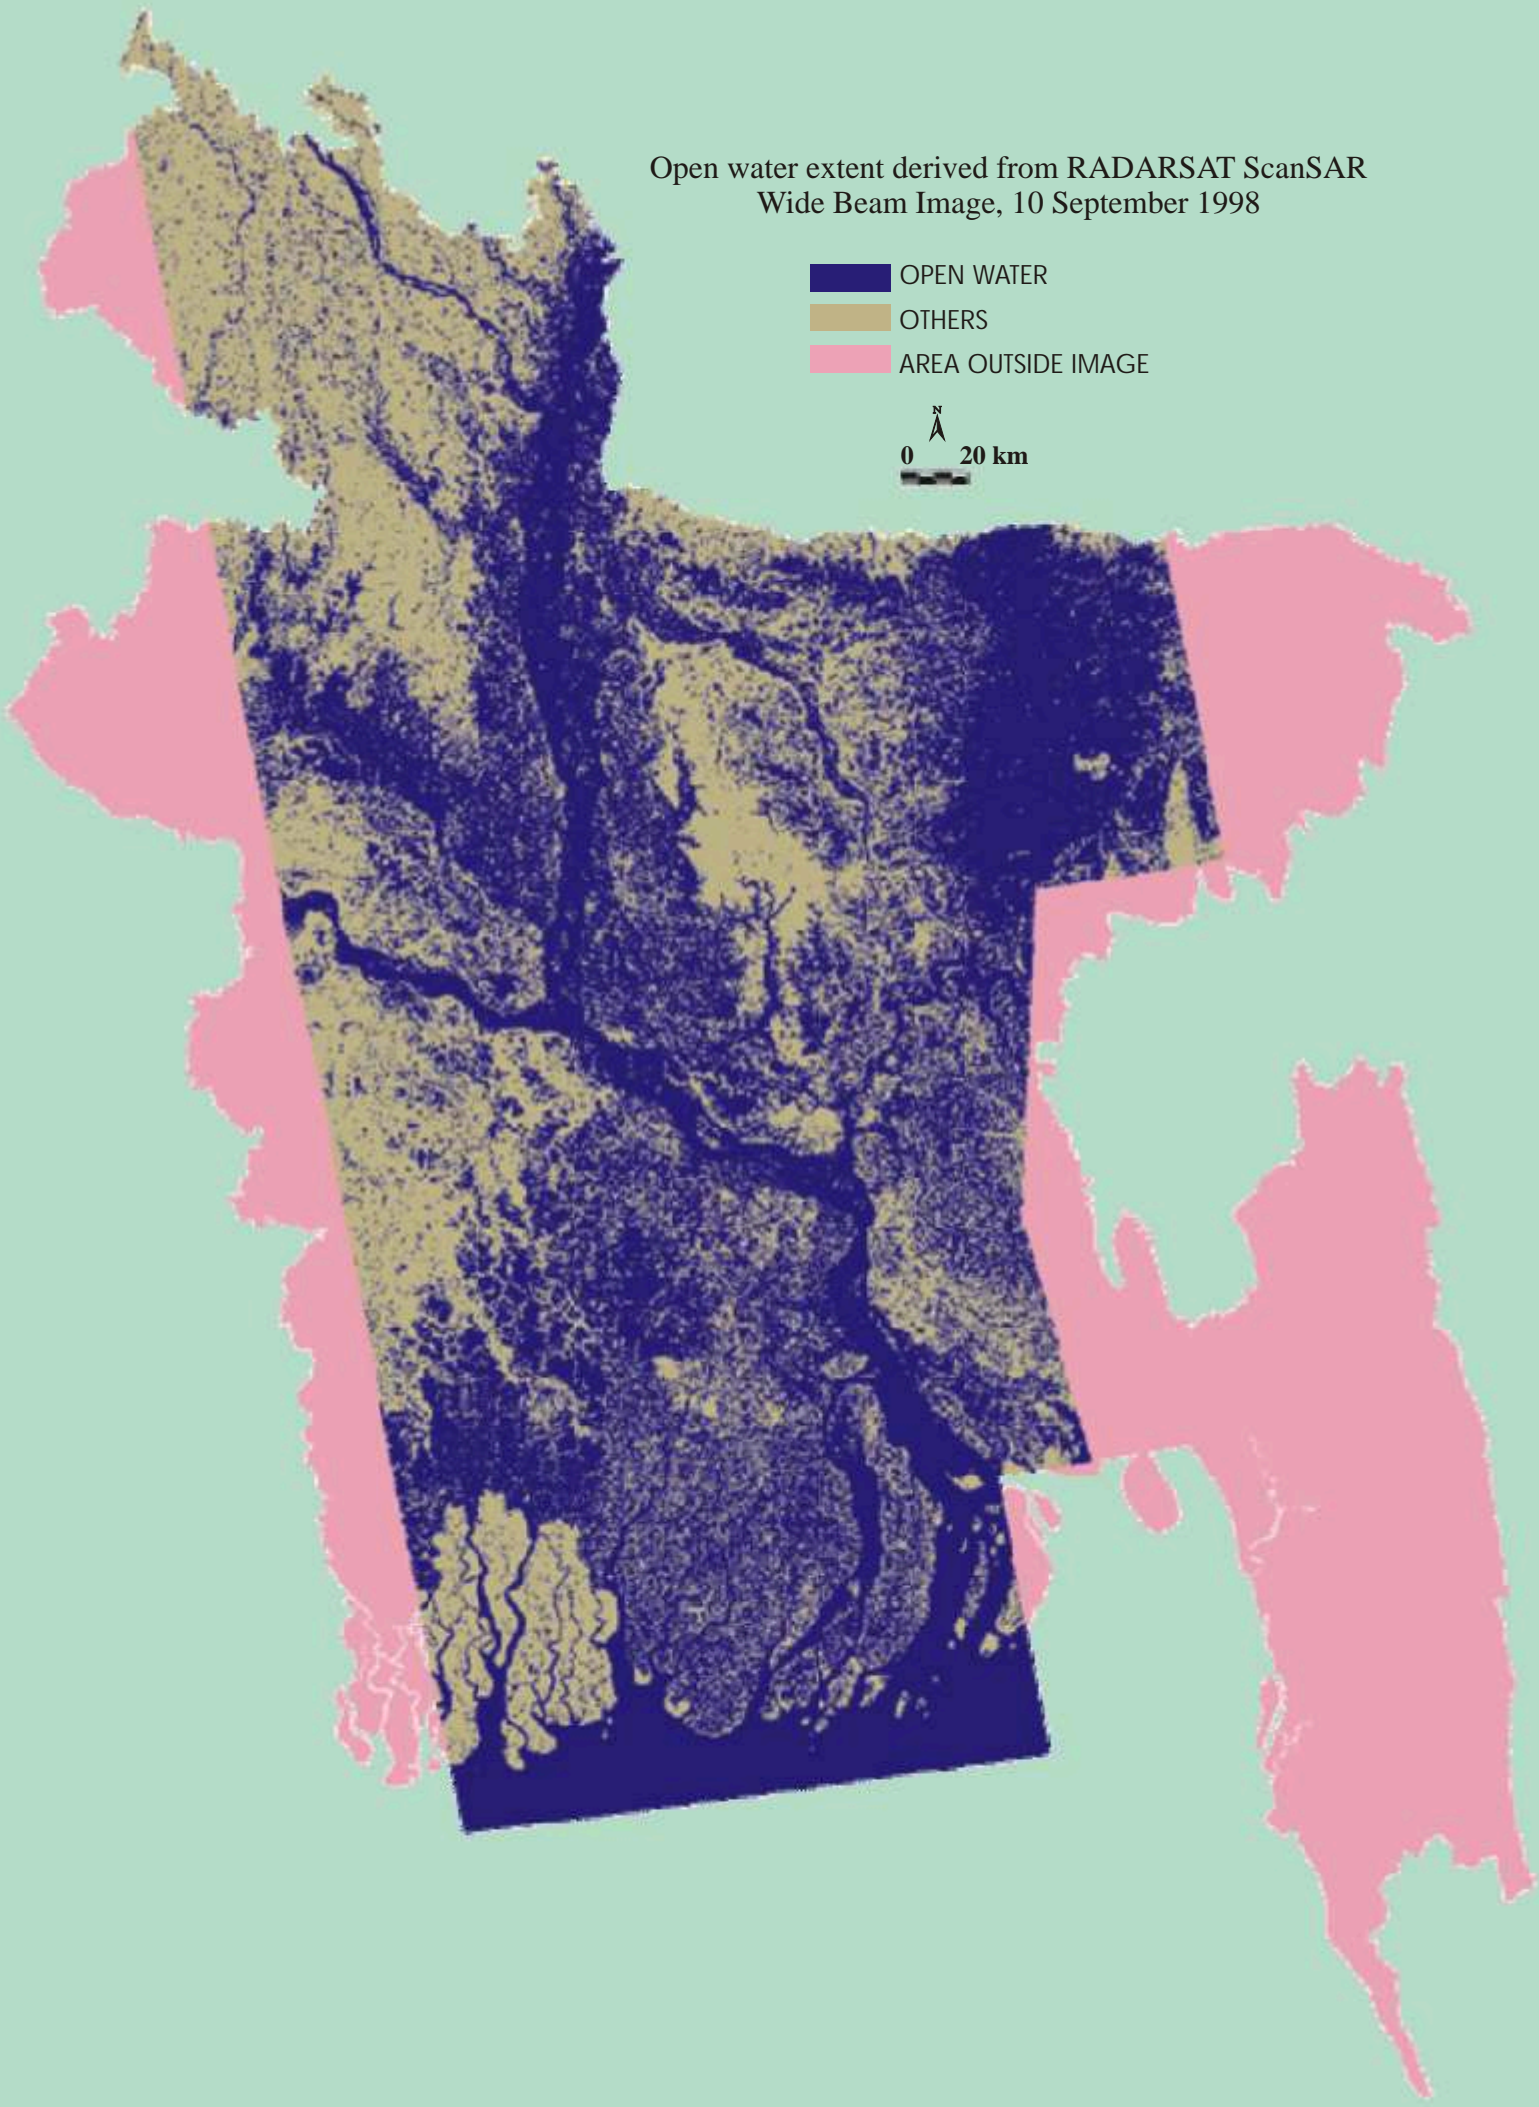
Satellite based radar image for mapping and monitoring floods of 1998

Open water extent derived from RADARSAT ScanSAR
Wide Beam Image, 10 September 1998

- OPEN WATER
- OTHERS
- AREA OUTSIDE IMAGE

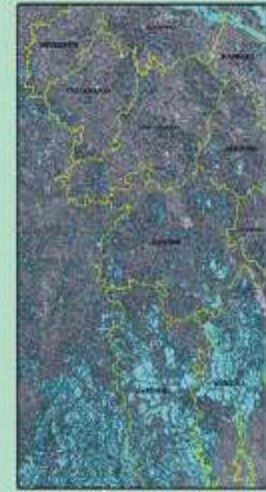
RadarSat image of 13 August 2000 showing open water in blue.

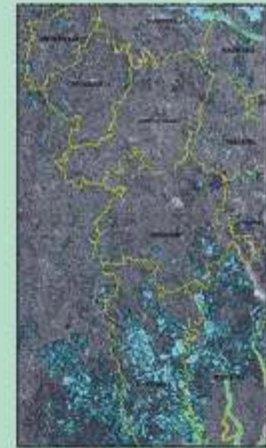
RadarSat image of 06 September 2000 showing open water in blue.

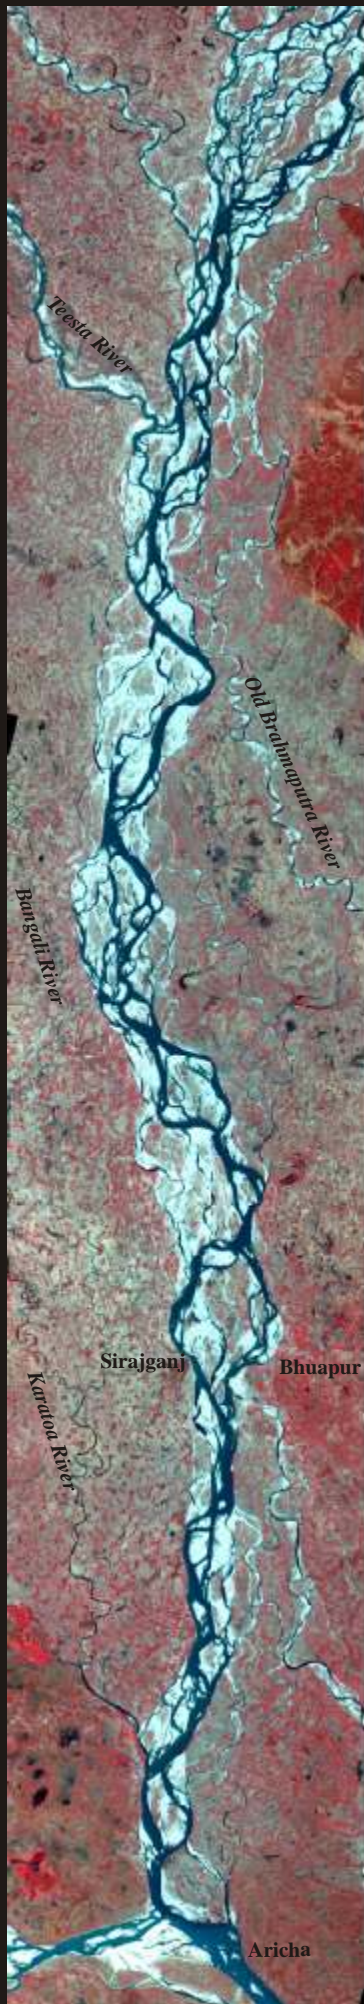
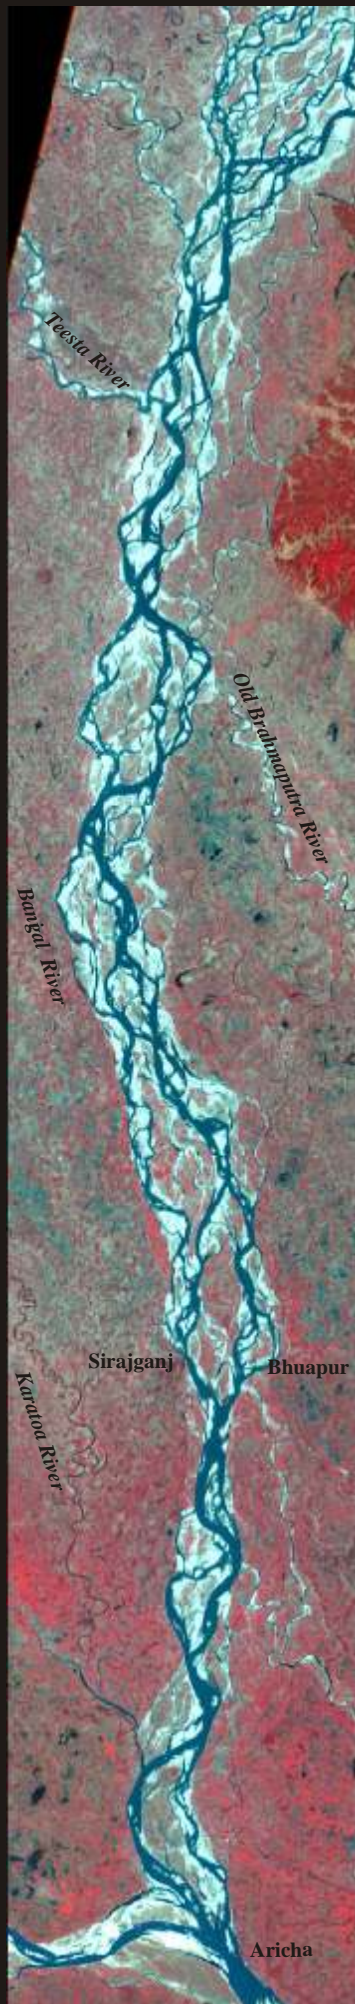
Satellite images of the Jamuna River 1973 - 2002

Digital image processing and GIS techniques help quantify and map morphological changes from the time series of images.
